Porsche 997: Defective vacuum lines of the servo brake

Beitrag von „Albert Motorsport“ vom 14. Dezember 2022, 08:19

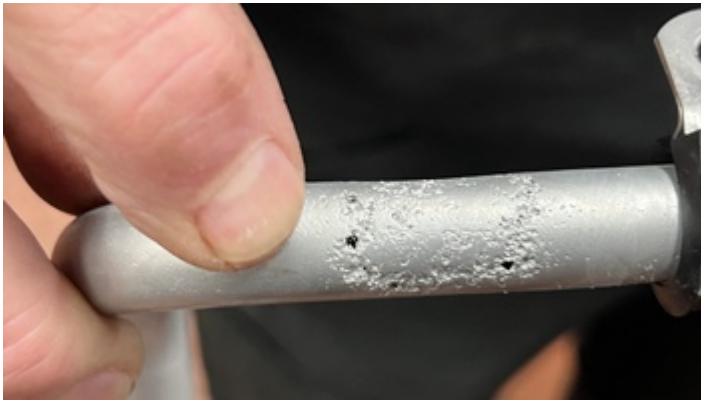
During our [engine revisions](#), damage to the vacuum lines of the servo brakes on Porsche 911 - 997 vehicles has been found several times.

The lines are made of bare aluminum and very often have severe pitting. This pitting, a form of corrosion, takes place just below the rubber-protected sheet metal brackets.

Due to the pitting, the vacuum to the servo brake is not built up or is only built up insufficiently, because air can flow in.

In addition, air is continuously sucked in by the engine outside of the air mass meter and so the measurement results for the injection are falsified.

To check the line must be removed because the damage is just below the clamps and is "NOT" visible from the outside.

For the reasons mentioned above, I think it is urgently necessary to have these vacuum air lines of the brake checked by a competent person in your Porsche center and replaced if necessary.

The latest generation of these 997 vacuum lines has solid surface protection!
