Can steel cylinders be used for Porsche engine repairs?

Beitrag von „Albert Motorsport“ vom 26. Oktober 2022, 10:15

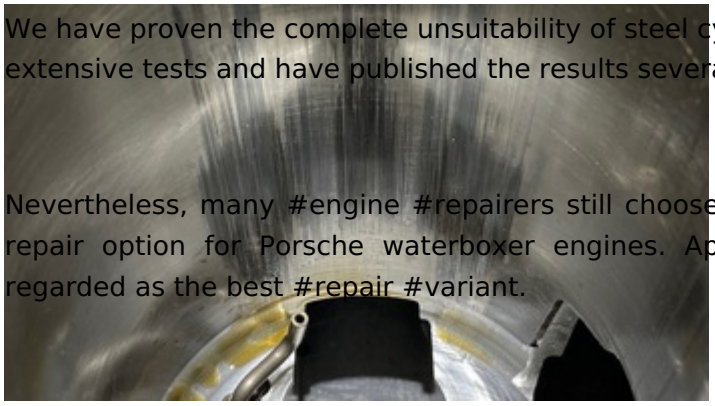
Of course, again with the unstable, wafer-thin steel cylinders, and again as cheaply as possible, partly with used bearings and again only with insufficiently renewed wearing parts. What should you say to our dear customer, except: "Sincere condolences"?

The customer drove the car on the freeway, after which the rattling noise was heard. A rattling noise in the engine is usually a sign of mechanical damage, in this case it is piston seizure on all cylinders.

Piston seizures happen in amateurishly repaired engines when either the lubrication is too low, the thermal expansion of the pistons / cylinders was calculated incorrectly, so that the pistons simply jam inside the cylinders during operation and then break, or the cylinders are exposed to the heat not be able to dissipate to the block or the water fast enough not to block the engine.

Here, in this case, a new complete revision is required. We will try to get the unstable old pressed-in cylinders out of the block without causing further damage. Then we have to use our cylinder graphite material to make cylinders adapted to the block and then install them in the engine with new, forged pistons and new wearing parts.

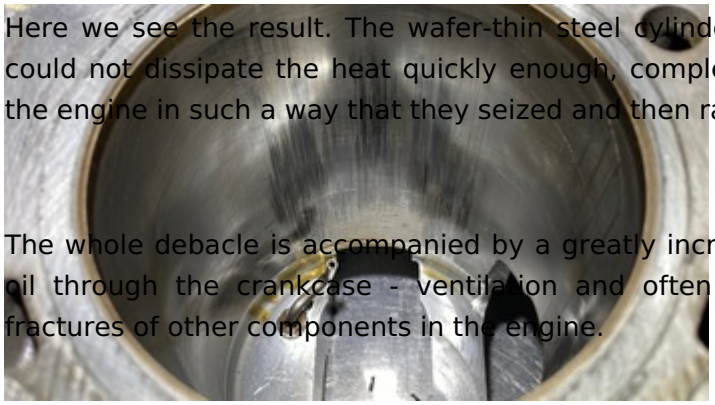
Once again we have received engine damage where the customer only drove the car a few kilometers without the previous owner telling him in advance that the engine had already been repaired.

Here we see the result. The wafer-thin steel cylinders without emergency running properties could not dissipate the heat quickly enough, completely deformed and blocked the pistons in the engine in such a way that they seized and then rattled.
