Porsche 997: Defective vacuum lines of the servo brake

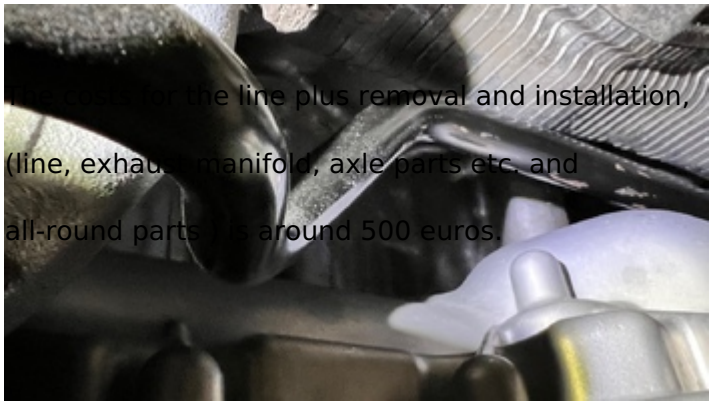
During our engine revisions, damage to the vacuum lines of the servo brakes on Porsche 911 - 997 vehicles has been found several times.

The lines are made of bare aluminum and very often have severe pitting. This pitting, a form of corrosion, takes place just below the rubber-protected sheet metal brackets.

Due to the pitting, the vacuum to the servo brake is not built up or is only built up insufficiently, because air can flow in.

In addition, air is continuously sucked in by the engine outside of the air mass meter and so the measurement results for the injection are falsified.

The latest generation of these 997 vacuum lines has solid surface protection!

To check the line must be removed because the damage is just below the clamps and is "NOT" visible from the outside.

For the reasons mentioned above, I think it is urgently necessary to have these vacuum air lines of the brake checked by a competent person in your Porsche center and replaced if necessary.

The costs for the line plus removal and installation, (line, exhaust manifold, axle parts etc. and all-round parts) is around 500 euros.
